A Supplemental Report Issued Following Hurricane Harvey

# Examination of Selected Assertions by U.S. EPA in the Proposed Remedial Action Plan for the San Jacinto River Waste Pits Superfund Site

**Doug Shields, Jr., Ph.D., P.E., D.WRE**

October 6, 2017

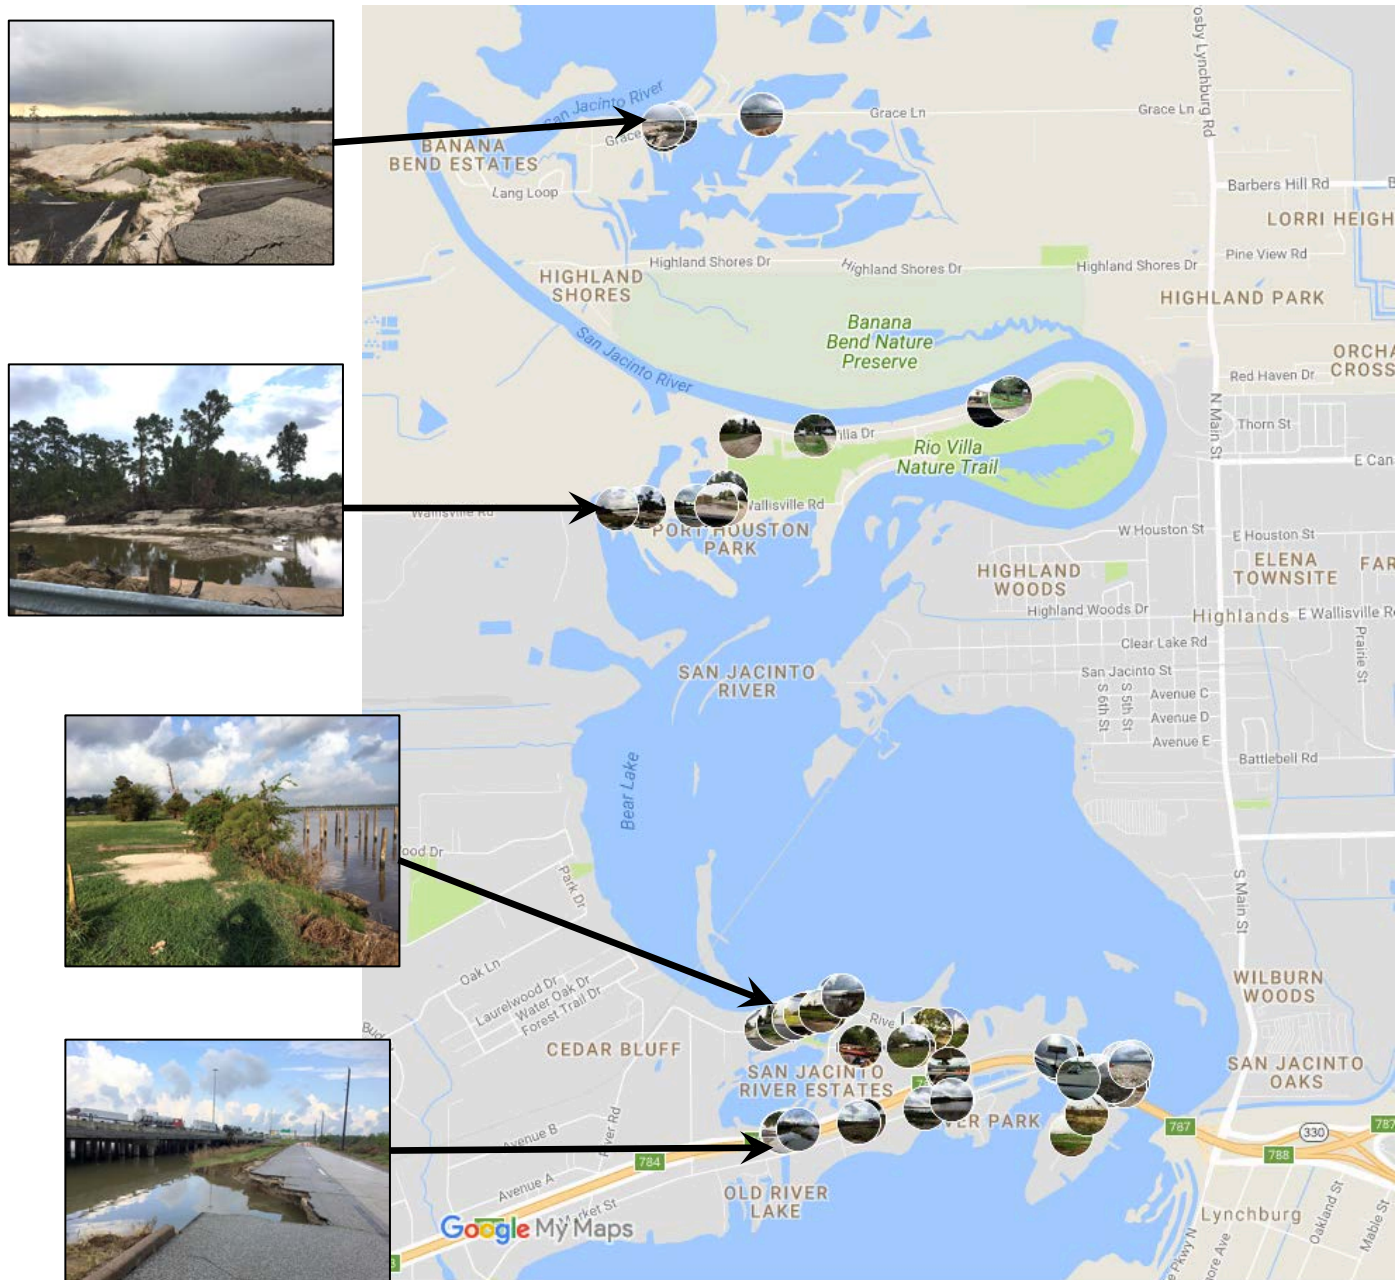
I visited the Site and its environs on September 21, 2017. Locations visited and georeferenced digital photos taken on that date are indexed in Figure 1 (all Figures are grouped at the end of this document). In addition, I have examined stage (water level) and discharge (rate of water flow) data collected during the storm, Site monitoring data collected since the storm, satellite and aerial photos taken before, during and after the storm, and output from a hydrodynamic computer model (Anchor QEA 2010) that was used to simulate water depths and current velocities in the river corridor in which the Site is located during the flood event associated with the passage of Hurricane Harvey (Keith et al. 2017).

Figure 1. Locations inspected on 9/21/2017. Photographs represent observed extreme erosion.

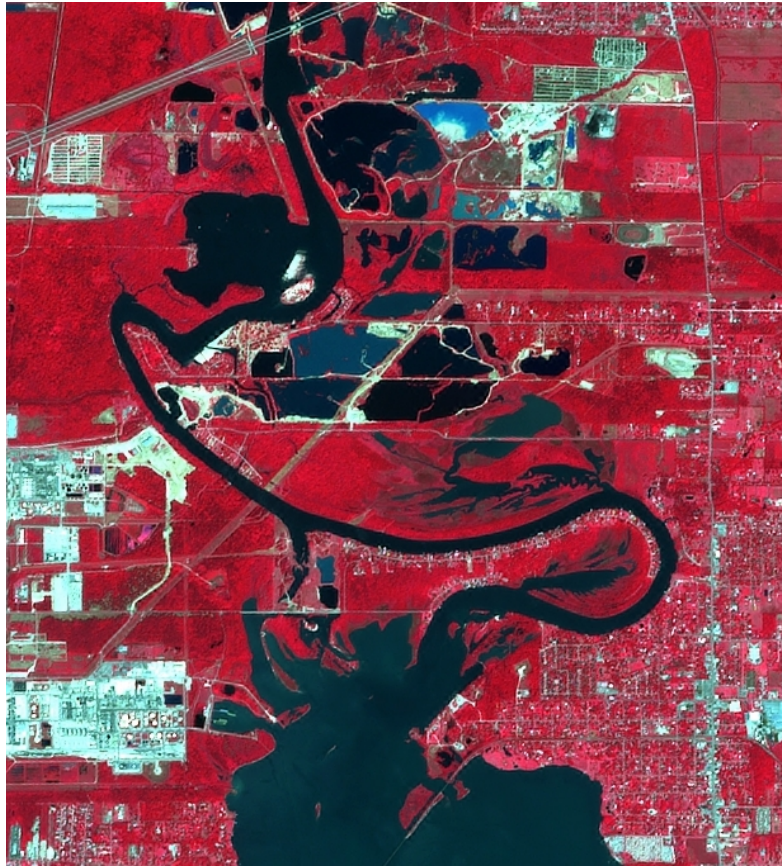
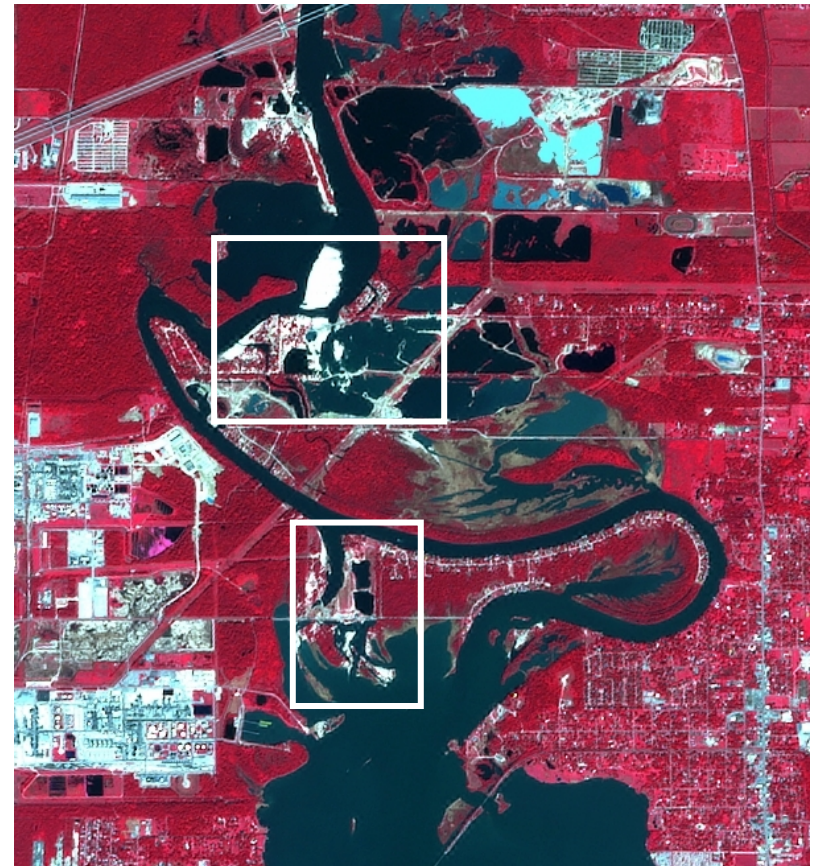
Comparison of the color infrared images confirmed impressions made by the on-the-ground visual inspection (Figures 3 and 4). Channel activity was limited to a reach beginning about 2.3 miles below the Lake Houston Dam to about 5.3 miles below the dam and that reach begins about 1.9 miles above the existing TCRA Armored Cap (straight-line distances). Fresh sediment deposits were more common than erosion; both along the channel margins, in the form of mid-channel bars, and in overbank areas subjected to flow (Figures 3a-d and 4a-d). Floodplain erosion and deposition associated with overbank flows existed in the same locations (Rio Villa in Banana Bend oxbow and Highland Shores in Banana Bend) as for the 1994 flood (Figure 3c), which were described in my January 2017 Report. There was also some floodplain erosion associated with overbank flow about 1.25 miles due east of the TCRA Armored Cap (Figure 3d) that was noted in the on-the-ground reconnaissance (Figure 1). However, as in 1994, eroded overbank channels did not capture river baseflow, and the river returned to its pre-flood channel as the flood receded (Figure 3a).

c. US Highway 90 to Bear Lake. White rectangles in October image highlight floodplain erosion and deposition.

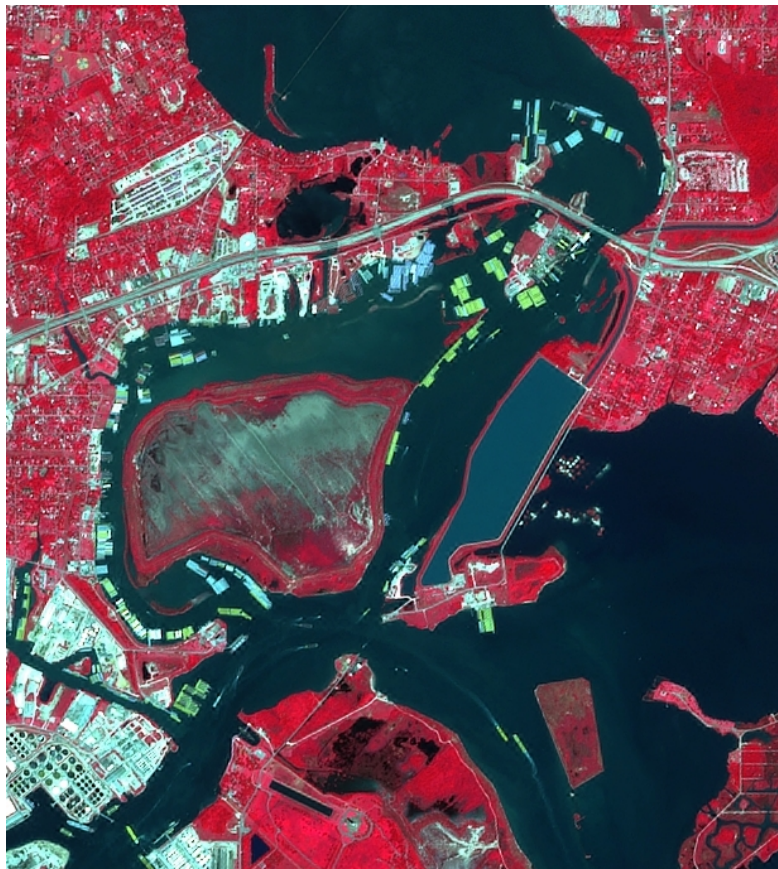
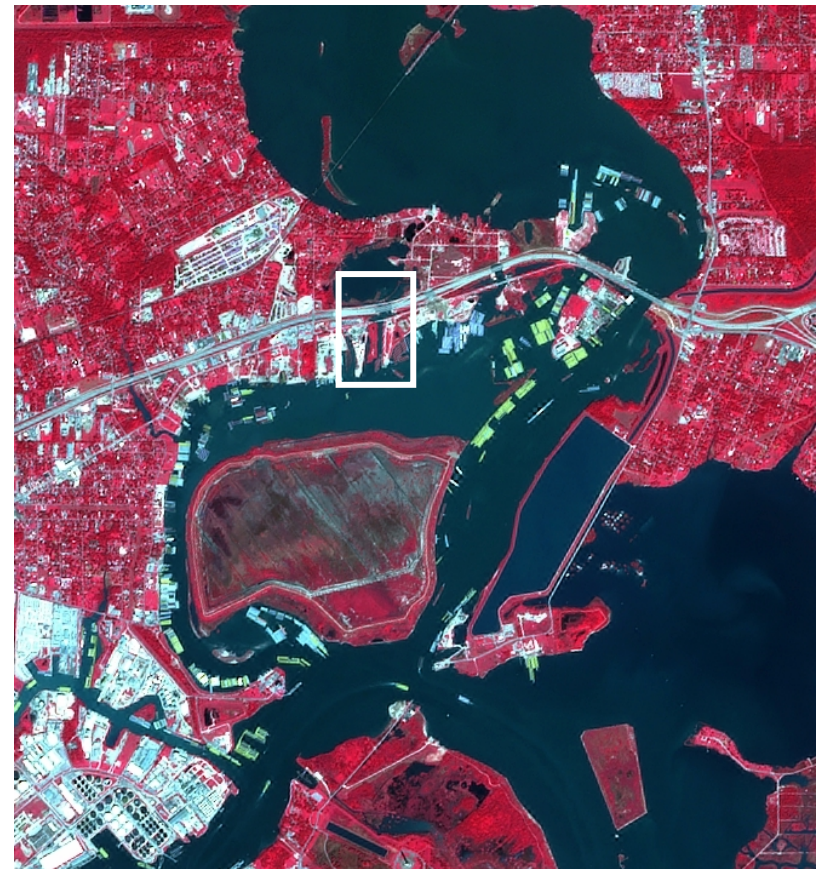
Highway 90 bridge, about 5.2 miles northwest of the existing TCRA Armored Cap (Figure 6b and c). The lack of erosion and deposition in the reach in which the Site is located (Figures 3d and 4d) was consistent with output from a 2D hydrodynamic computer model that was used to simulate passage of the Hurricane Harvey event (hindcasting). Maximum simulated shear stresses along the shorelines and banks in this reach during the Hurricane Harvey event were generally well below  $1 \text{ Pa} = 0.02 \text{ lb/sq ft}$  (Figure 7), implying that they were less than levels that would initiate erosion of floodplain soils (Fischenich 2001) and generally below reported levels needed to erode cohesive bank sediments (Clark and Wynn 2007, Enlow et al. 2017).

d. Bear Lake to Buffalo Bayou. White rectangle on October image highlights floodplain erosion noted in on-the-ground field reconnaissance.

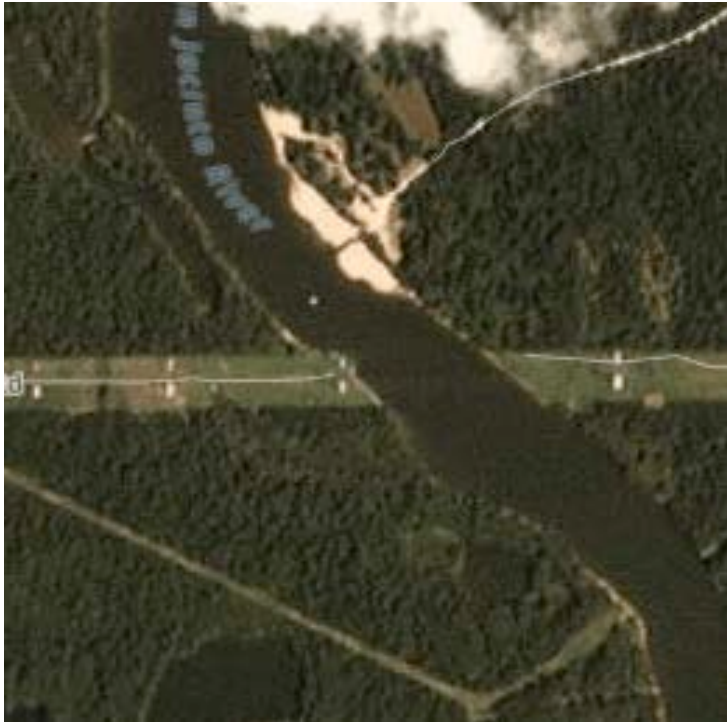
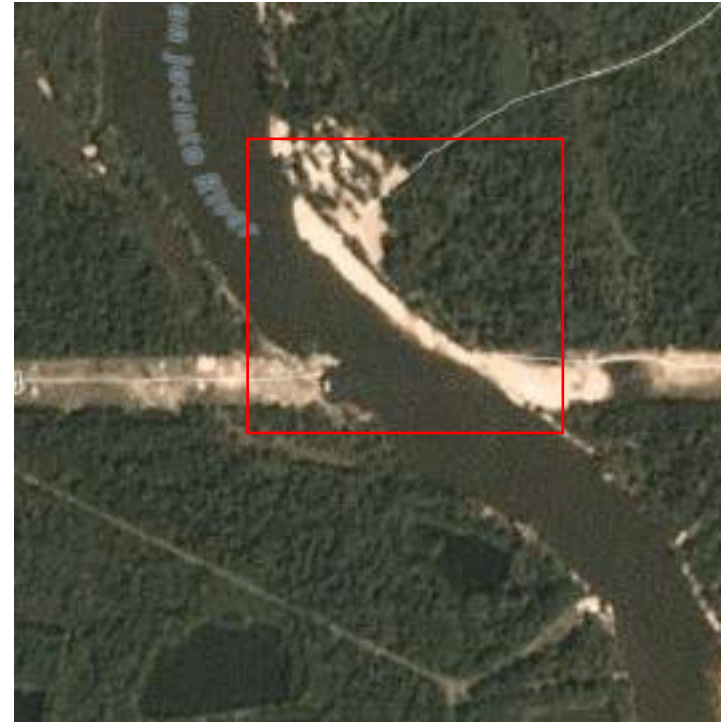
No major bank erosion was noted. The alignments of concave banks on the outside of bends were stable. Comparison of pre- and post-flood satellite imagery indicated bank erosion at three locations between the Lake Houston Dam and Muleshoe Lake, which is about 4.3 miles (straight line distance) upstream from the TCRA Armored Cap (Figure 6a-c). Channel width changes were limited to a reach extending about 0.6 miles up- and downstream of the U. S.

a. Bank erosion on east bank about 2.2 miles SE of Lake Houston Dam.

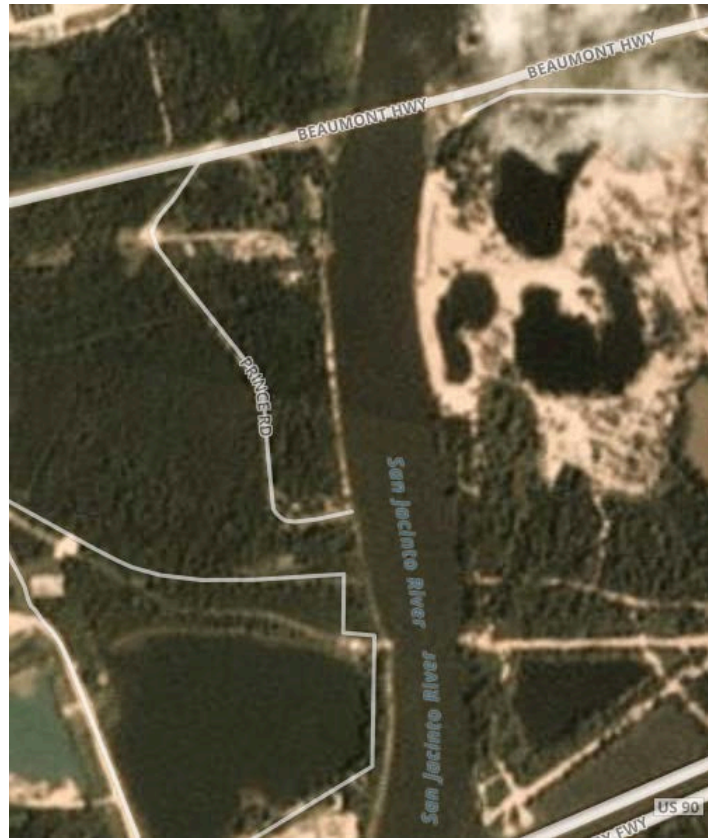
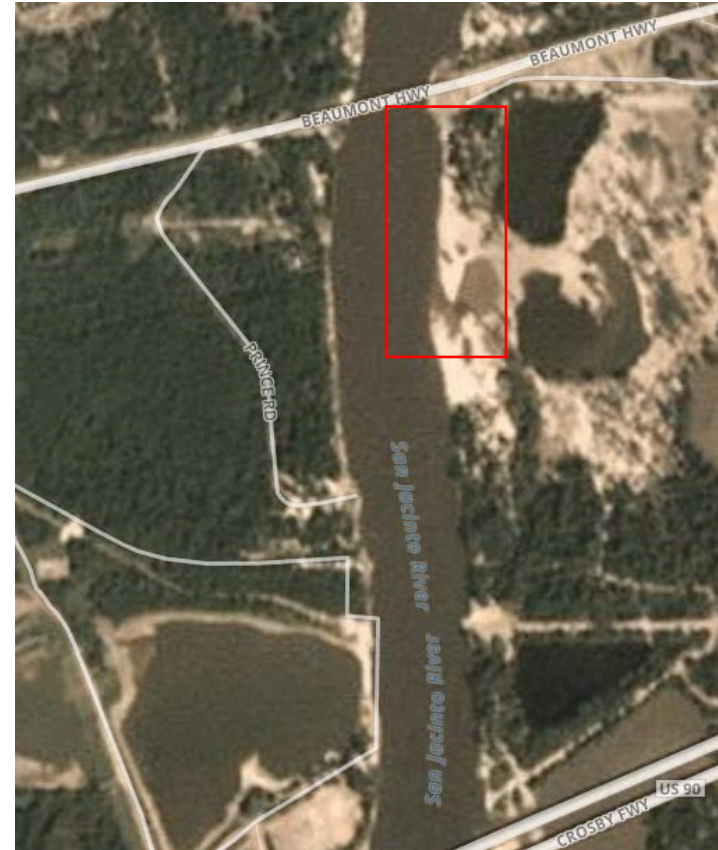
b. Bank erosion on east bank about 4.0 miles SE of Lake Houston Dam.

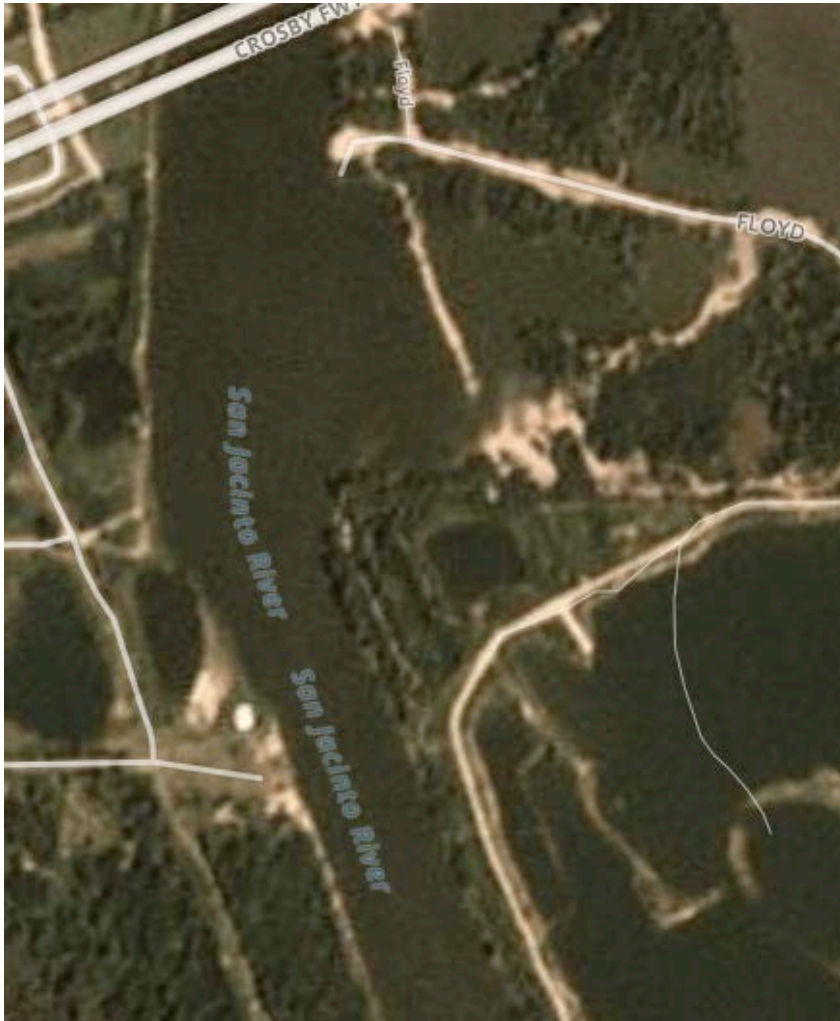
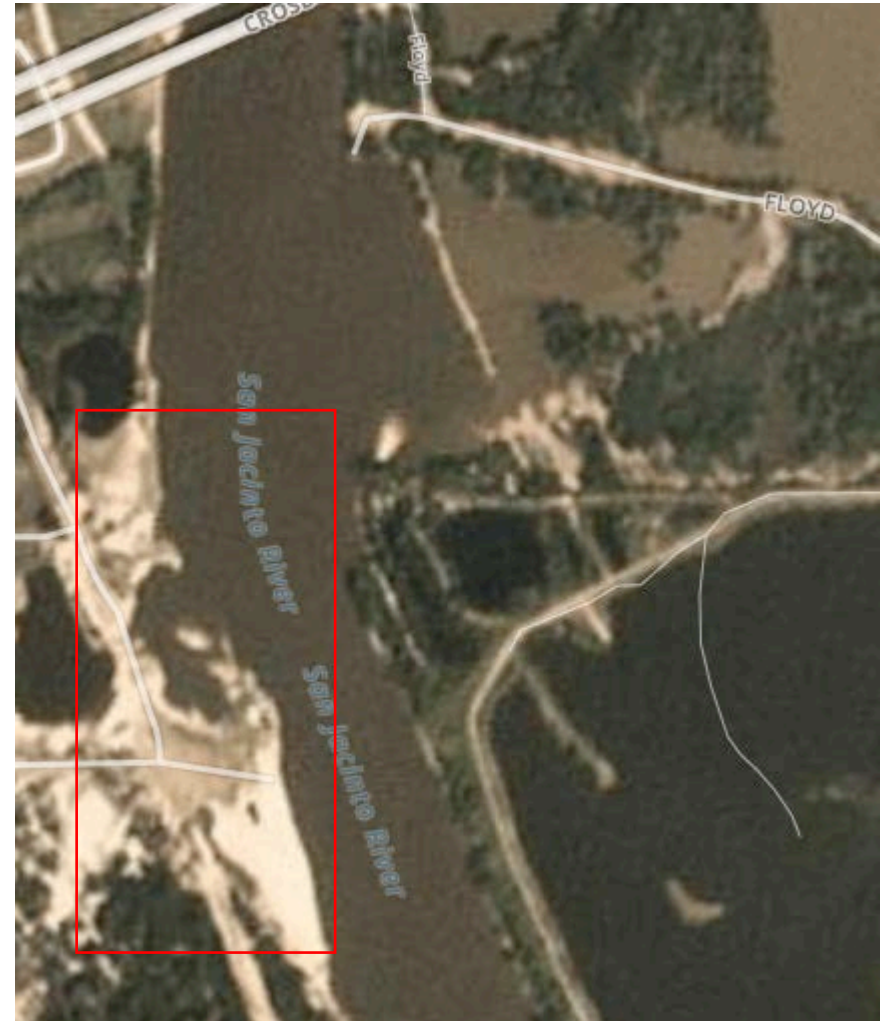
c. Bank erosion on west bank about 4.9 miles SE of Lake Houston Dam.

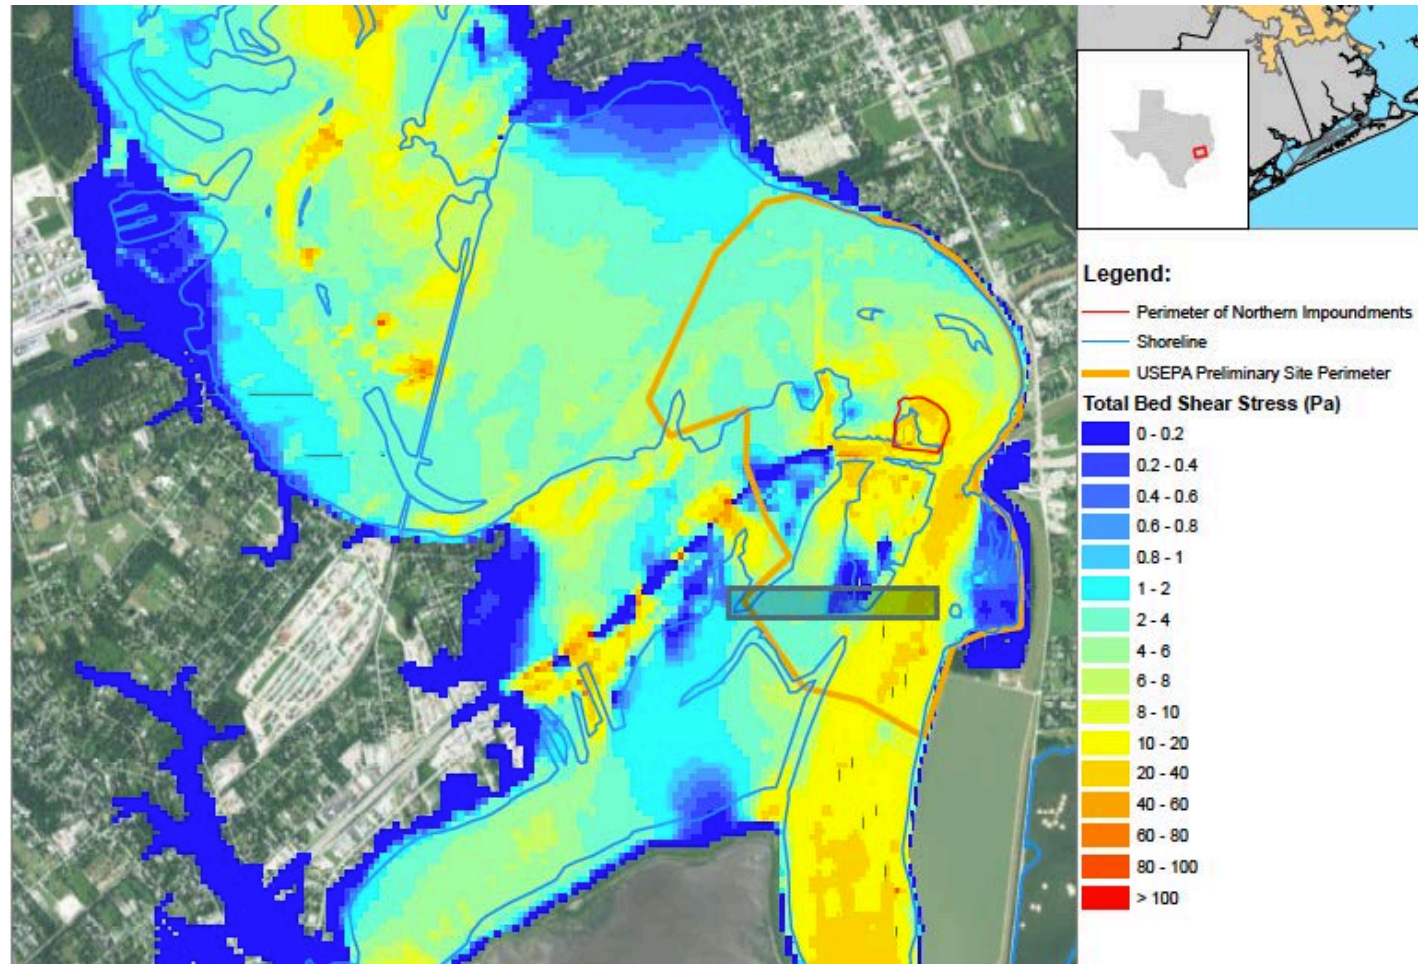
The Anchor computer model hindcast the peak Hurricane Harvey storm hydraulic stresses on the TCRA Armored Cap and indicates that maximum current velocities approached but did not exceed those used in the TCRA design (depth-averaged current velocities of 6.9 ft/s simulated vs. 8.5 ft/s used in design) (Keith et al. 2017, Anchor QEA 2010). These results are consistent with the very minor displacement of stones in the TCRA Armored Cap that were detected following Hurricane Harvey.

Figure 7. Simulated maximum total bed shear stress during Hurricane Harvey using Lake Houston Dam flow for calibration. Anchor QEA (unpublished).
